Manhole Inspection Summary

Manhole # S47Y1_002MH

Insp Date: **6/2/09 1:05 PM**

Location Address: **1301 Chesapeake Ave.**

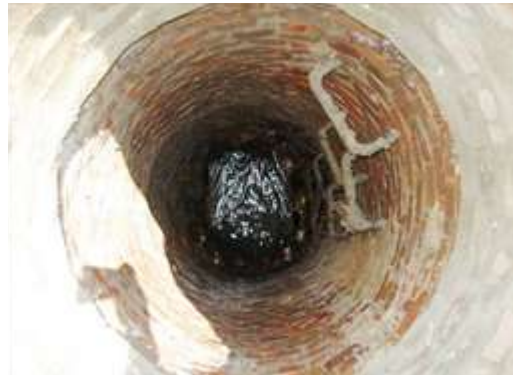
Top View

Comments **Heavy deposits in barrel.**

Condition: ☐ Sound ☐ Cracked ☐ Root Intrusion ☒ **Loose Brick** ☒ **Deteriorated**

Infiltration: ☐ None ☐ Joint ☐ Cracks ☐ Mortar ☐ Roots ☒ **Wall**

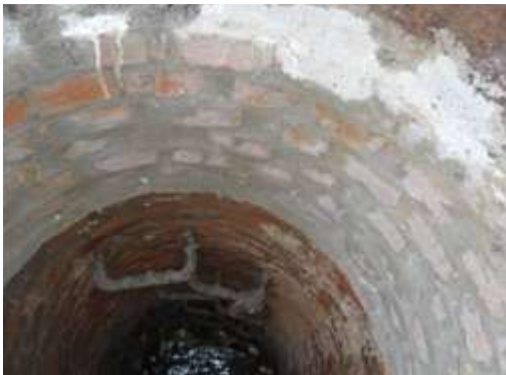
Steps Count: **11** Missing: **0** ☒ **Corroded**

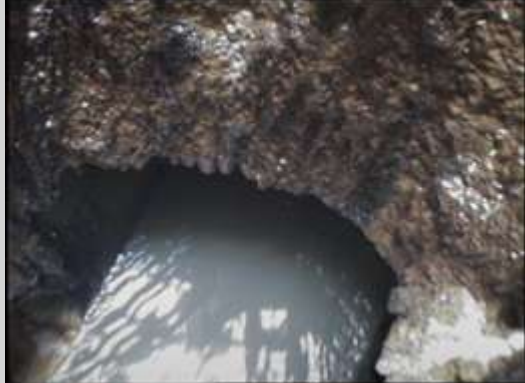
12 O'Clock Outflow

42 in. Circular Gravity Sewer
Pipe Out @ 12 O'Clock

Pipe Height: **43.2** (in.) Rod and Bar (Angled)
Pipe Material: **Concrete** ☐ Pipe Lined
Invert Depth: **19.66** (ft.) Flow Characteristics: **Fast**
Deposits: ☒ None ☐ Mud ☐ Sludge ☐ Debris ☐ Grease
Silt Depth: (in.) Deposits Extent:
Infiltration: **None** Pipe Seal Cond: **Sound**

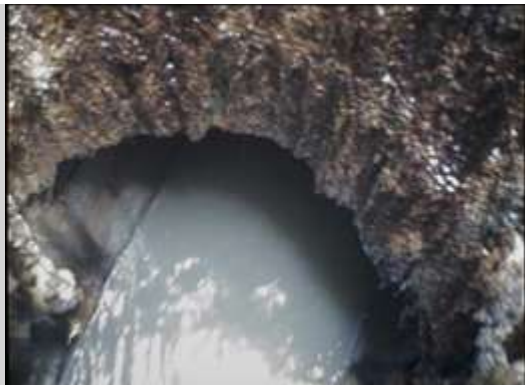
6 O'Clock Inflow

42 in. Circular Gravity Sewer
Pipe In @ 6 O'Clock

Pipe Height: **42** (in.) Rod and Bar (Angled)
Pipe Material: **Concrete** ☐ Pipe Lined
Invert Depth: **19.62** (ft.) Flow Characteristics: **Fast**
Deposits: ☒ None ☐ Mud ☐ Sludge ☐ Debris ☐ Grease
Silt Depth: (in.) Deposits Extent:
Infiltration: **None** Pipe Seal Cond: **Sound**
